14.0 Rifle, Colorado, Disposal Site

14.1 Compliance Summary

Figure 14-1. 2006 Annual Compliance Drawing for the Rifle, Colorado, Disposal Site

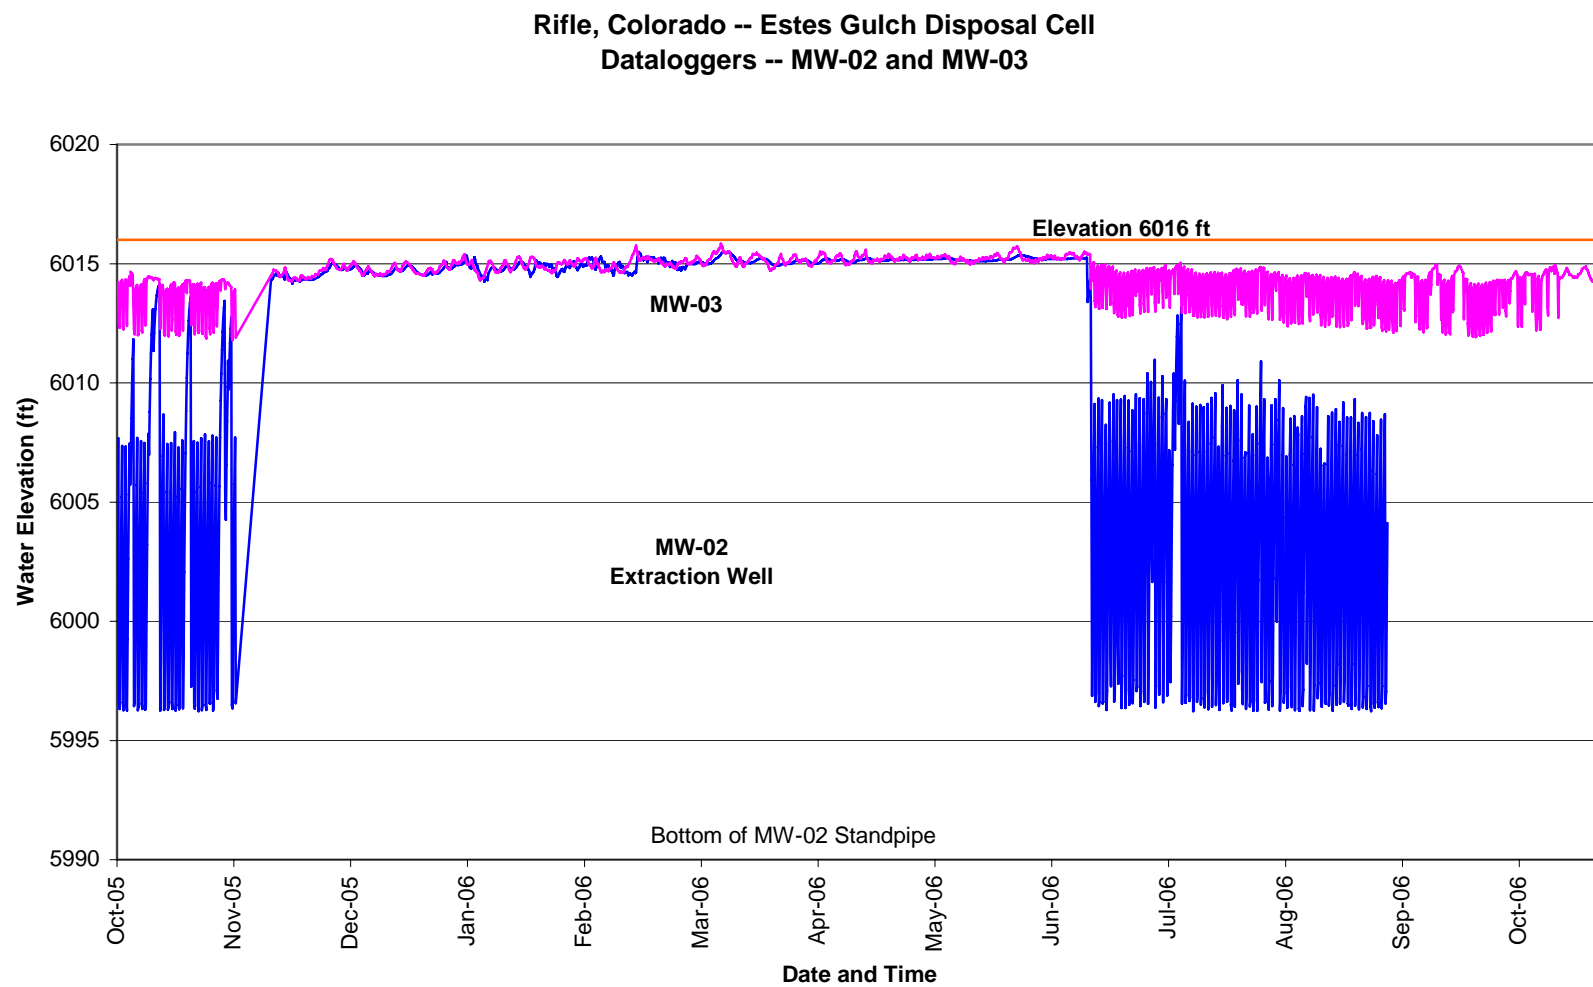
Figure 14-2. Disposal Cell Pore Water Levels in Standpipes MW-02 and MW-03 at the Rifle, Colorado, Disposal Site.

As shown by datalogger measurements (Figure 14-2), over the past year during pumping water levels initially decreased sharply followed by a steadier continuous decline, only rising in correspondence to precipitation events. The water level elevation remained below 6,015 feet in both standpipes. Datalogger malfunction in MW-02 resulted in lost water level data from late August through late October (when the pumps were shut off); because water levels in this well historically have remained significantly below the action level, and also below the water levels recorded in MW-03, there was no concern that the action level had been exceeded. In support of this conclusion, the static water level measurements obtained in both standpipes MW-02 and MW-03 when the pumps were shut off on October 30, 2006, were below the action level. During this period of pumping (early June to late October), fluctuations in the water levels represent typical drawdown and recovery that occurs during pumping on/off cycles. The pumps were shut

Looking back to early November 2005 when the pumps were turned off for the winter, water levels increased to 6015 feet within a relatively short time and then very slowly increased over the winter toward the action level of 6016 feet. The water levels did not reach the action level before pumping was resumed in early June 2006.

To date, approximately 3.8 million gallons of water have been pumped from the disposal cell. This includes the volume pumped during construction of the disposal cell and the volume pumped since dewatering was initiated again in 2001. The rapid recovery of the water levels in the standpipes to approximately 6,015 feet after pumping is discontinued, and the slow recovery afterward toward the 6,016-foot action level over the next six months, suggests a large reservoir of water remaining in the disposal cell.

DOE intends to remove enough water from the disposal cell to lower water levels in the standpipes to below the 6,014-foot elevation. At that time, pumping will be stopped, and water levels will be monitored to ensure they remain at or below that elevation. If water levels again rise, pumping will resume.

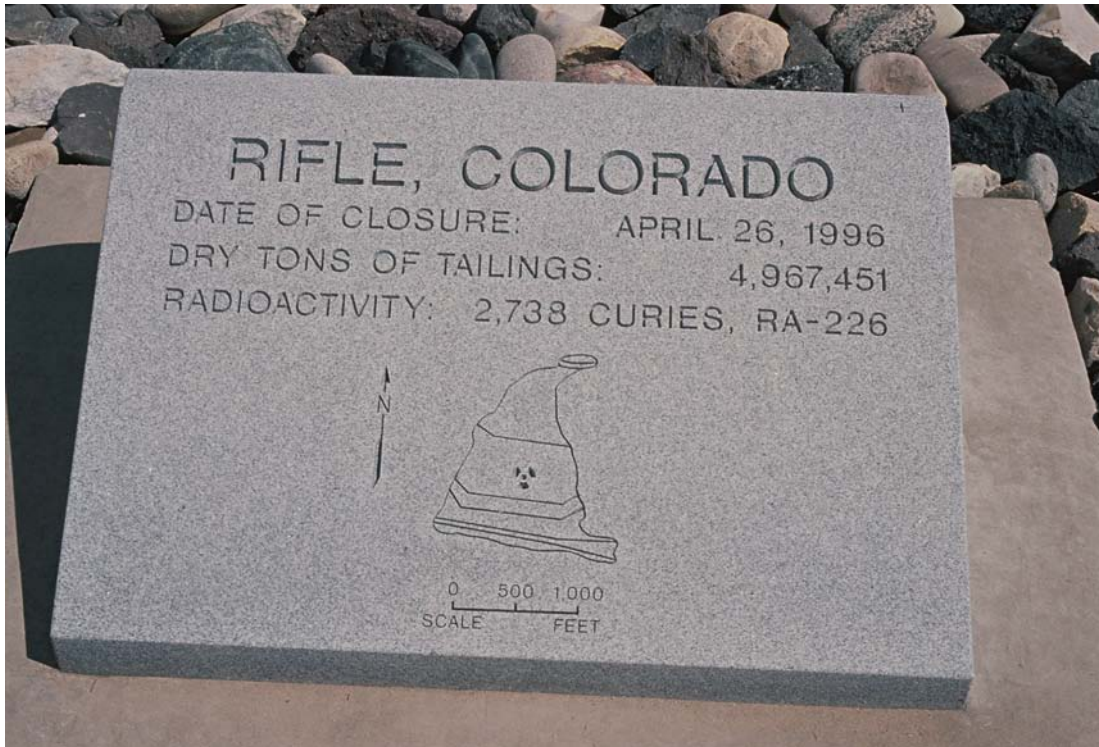
Markers and Monuments—Two granite site markers, one just inside and left of the entrance gate and the other on the disposal cell, were undisturbed and in good condition (PL–1).

RFL 8/2006. PL-1. Site marker #1 on top of the disposal cell.

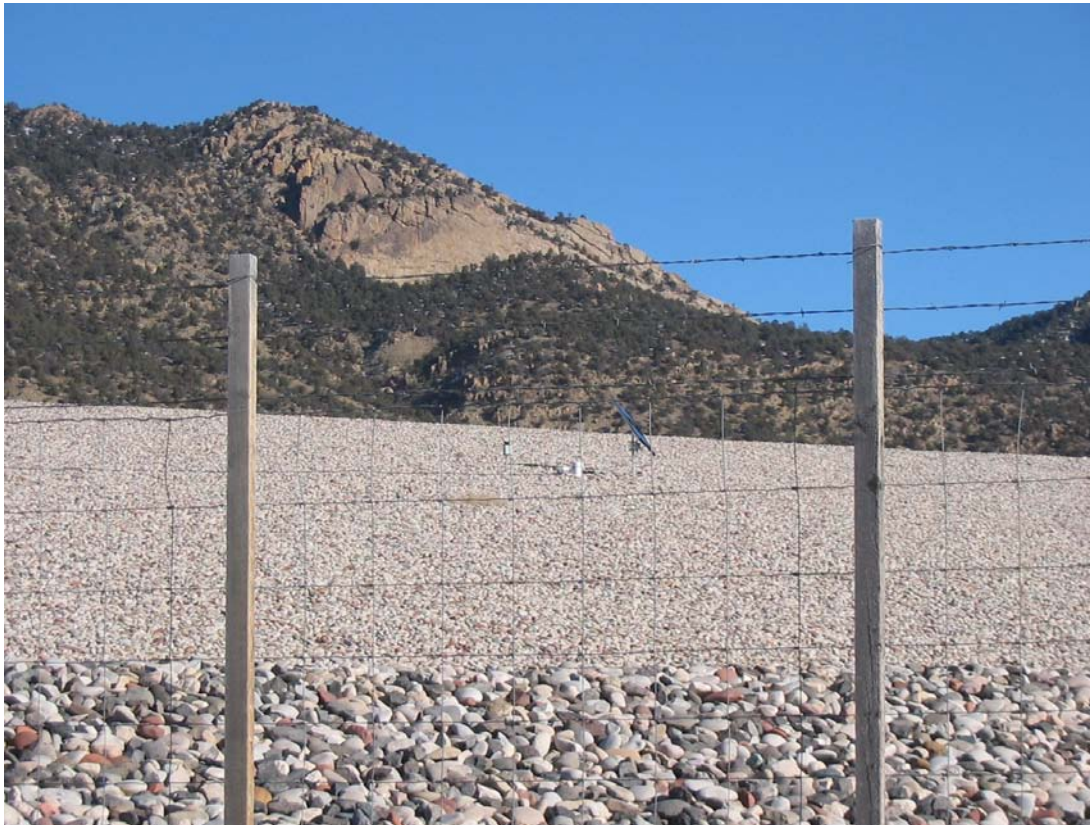
fluctuations. Information from this instrumentation is transmitted via cellular telephone technology to an internet connection where the data can be retrieved. These two standpipes have solar-powered pumps (PL-2) that discharge water through small-diameter aboveground plastic pipelines to a lined evaporation pond. The solar collectors are designed to automatically follow the position of the sun for optimal performance. There is no datalogger or pump in MW-01 because it is too shallow and usually dry. Water level data collected from these two standpipes are presented below in Section 14.3.4.

RFL 8/2006. PL-2. Standpipe MW-02 and associated solar collector for solar powered submersible pump.

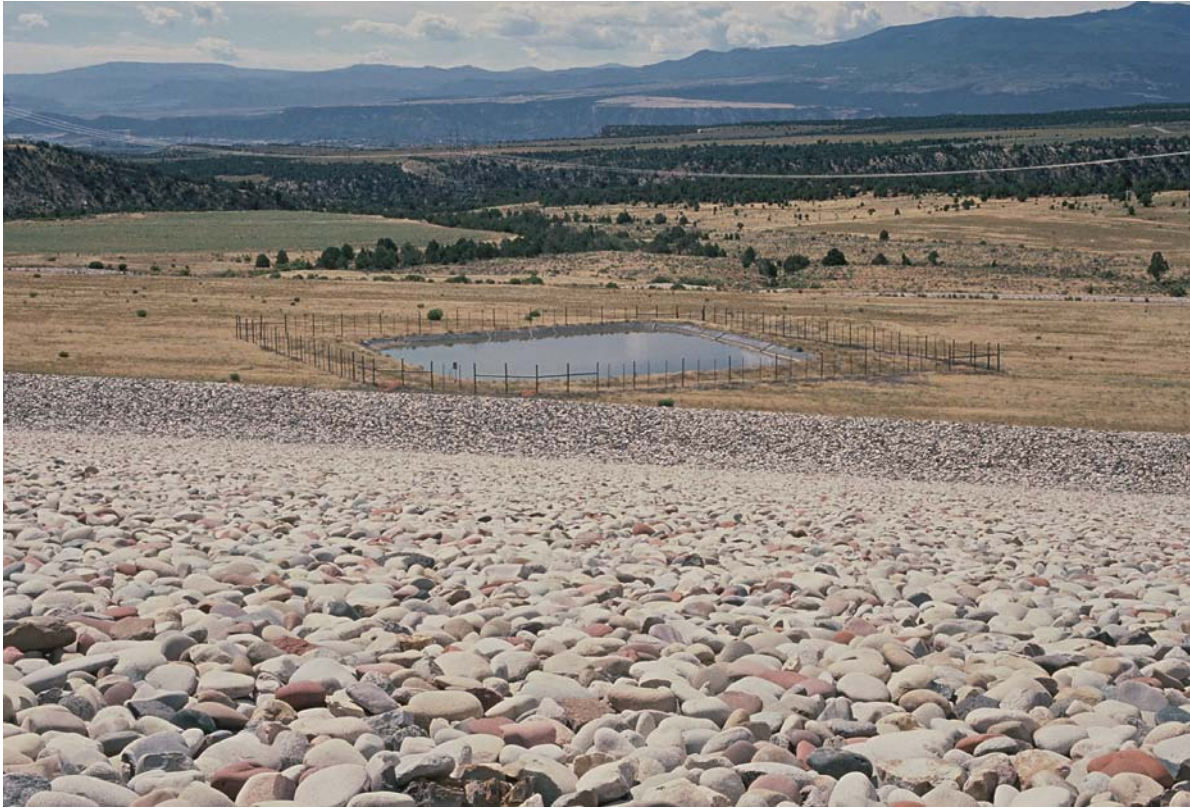
Evaporation Pond—An evaporation pond was constructed in 2001 to receive water pumped from standpipes MW-02 and MW-03. A datalogger, also with a remote data transfer system, is installed in the evaporation pond to measure water level fluctuations. The lined pond, surrounding security fence, and locked fence gate were in excellent condition (PL-3).

RFL 8/2006. PL-3. Evaporation pond directly south of the disposal cell.

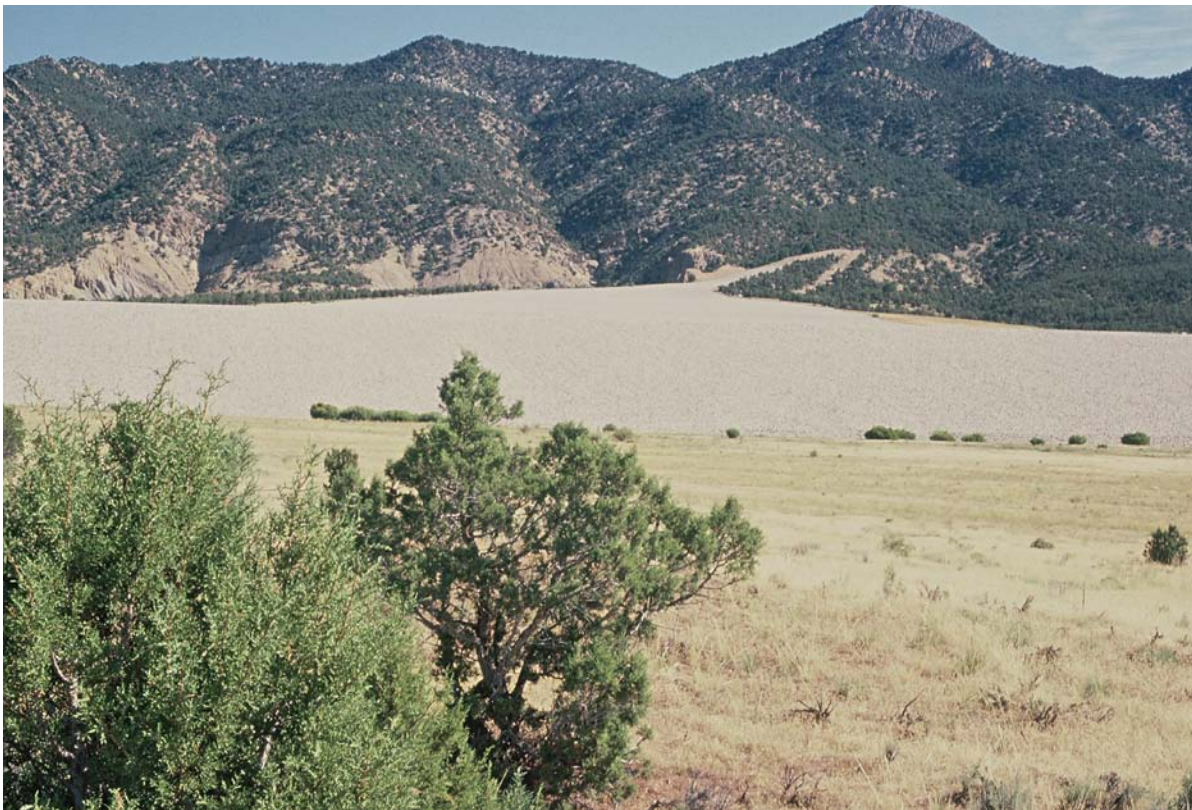
Disposal Cell and Interceptor Trench—Rock armor covering the 71-acre disposal cell was in excellent condition (PL-4). No evidence of subsidence, differential settlement, or slumping was found.

RFL 8/2006. PL-4. Disposal cell.

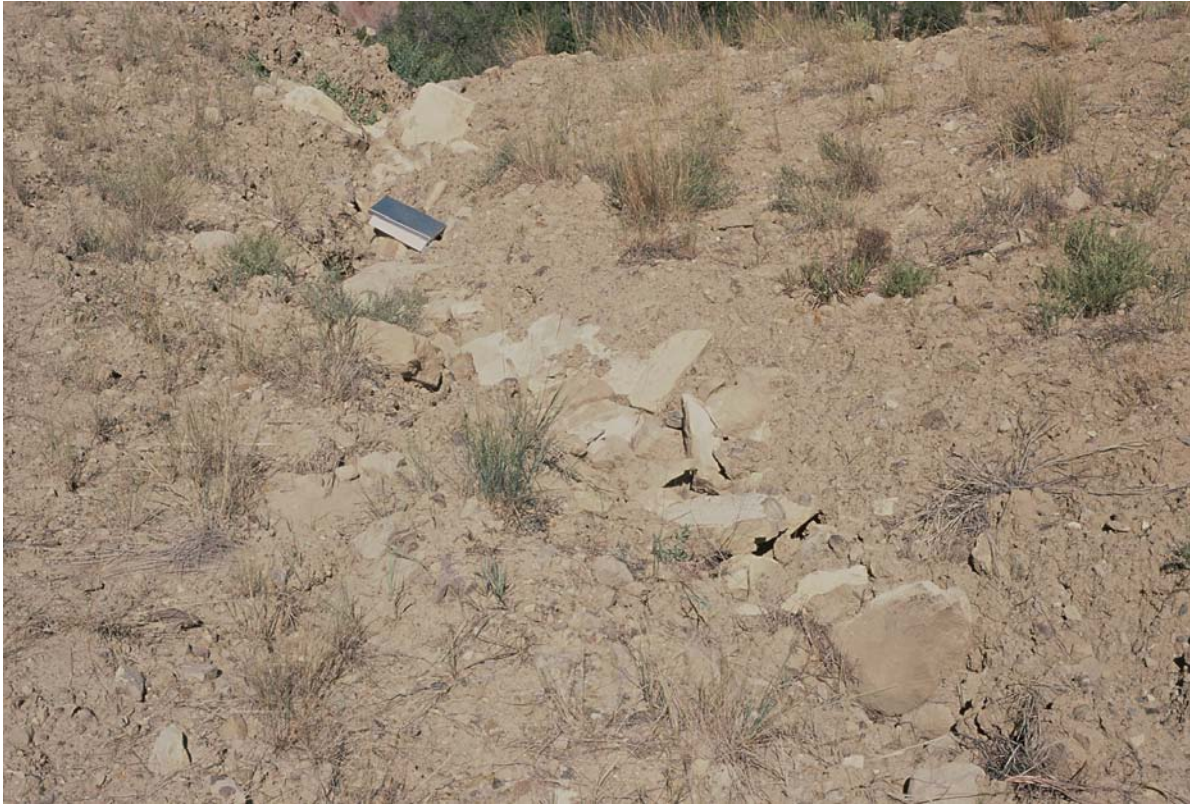
A revegetated interceptor trench was constructed at the top of the disposal cell to protect the cell from storm-water and snowmelt run-on. The trench diverts water to the arroyo west of the site. Significant erosion occurred during a major rain event in 2005 and repairs to the interceptor trench were considered necessary. Rocks were moved into the eroded channel and the erosion stabilized in November 2005. The area had no new erosion at the time of the 2006 inspection (PL-5). Monitoring of this trench will continue.

RFL 8/2006. PL-5. Erosion control in interceptor trench completed fall 2005, no new erosion.

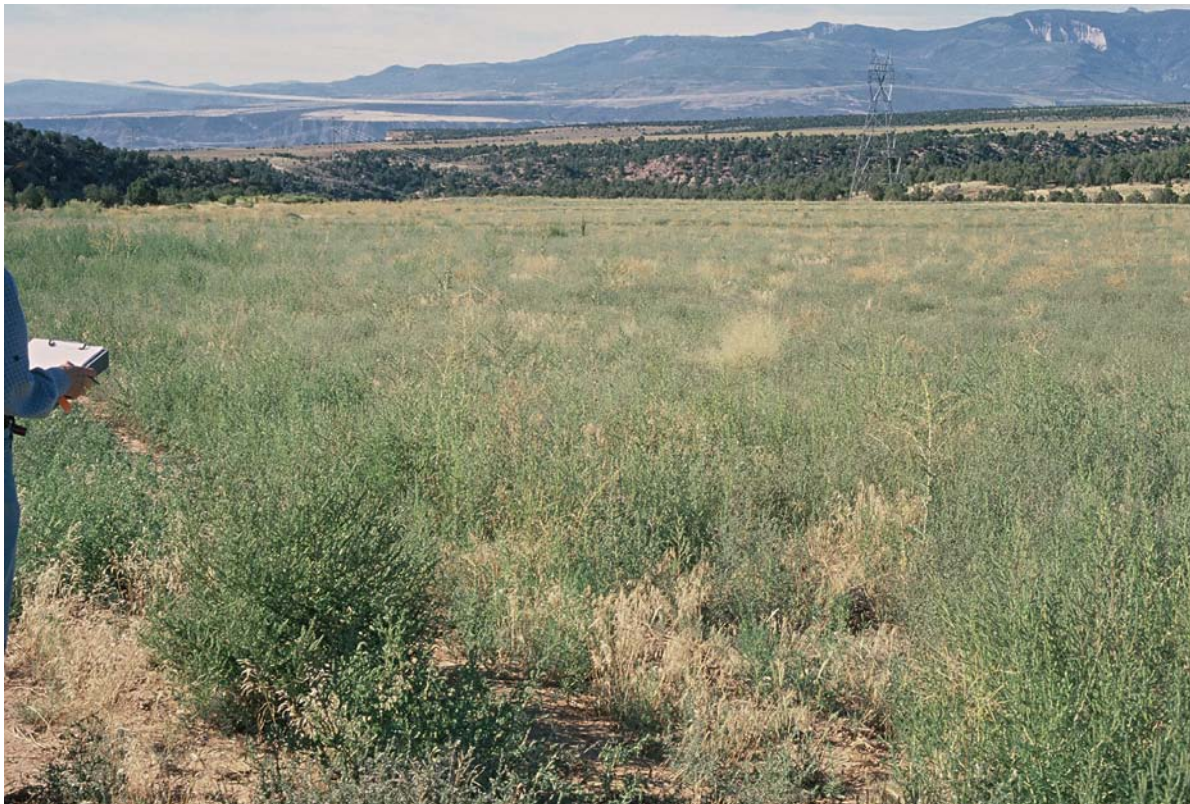
In 2005, a major effort was expended to reestablish desirable plants on the 16-acre area. The area was plowed and reseeded. Reclamation specialists visited the site in spring 2006 and noted that many of the desirable seeded species had germinated and that cover by cheatgrass had decreased dramatically. Following a dry hot summer, many of the desirable species that germinated did not survive which allowed annual weeds to take over the site. At the time of the 2006 inspection, annual weeds dominated plant cover throughout the 16-acre area (PL-6). The annual weed cover may provide shade and allow desirable perennial species to reestablish. No corrective action is recommended at this time and inspectors will continue to monitor plant composition in the area.

RFL 8/2006. PL-6. BLM Right of Way Reservation area south of disposal cell; plowed and reseeded in 2005.
